U.S. ENVIRONMENTAL PROTECTION AGENCY
POLLUTION/SITUATION REPORT
Morrow Lake Sediment Release - Removal Polrep
Initial Removal Polrep

Subject: POLREP #1
Initial - PRP Oversight
Morrow Lake Sediment Release
C5SC
Comstock, MI
Latitude: 42.2825160 Longitude: -85.4920006

From: Jeff Kimble, OSC
Date: 11/4/2020
Reporting Period: 10/05/2020 - 11/04/2020

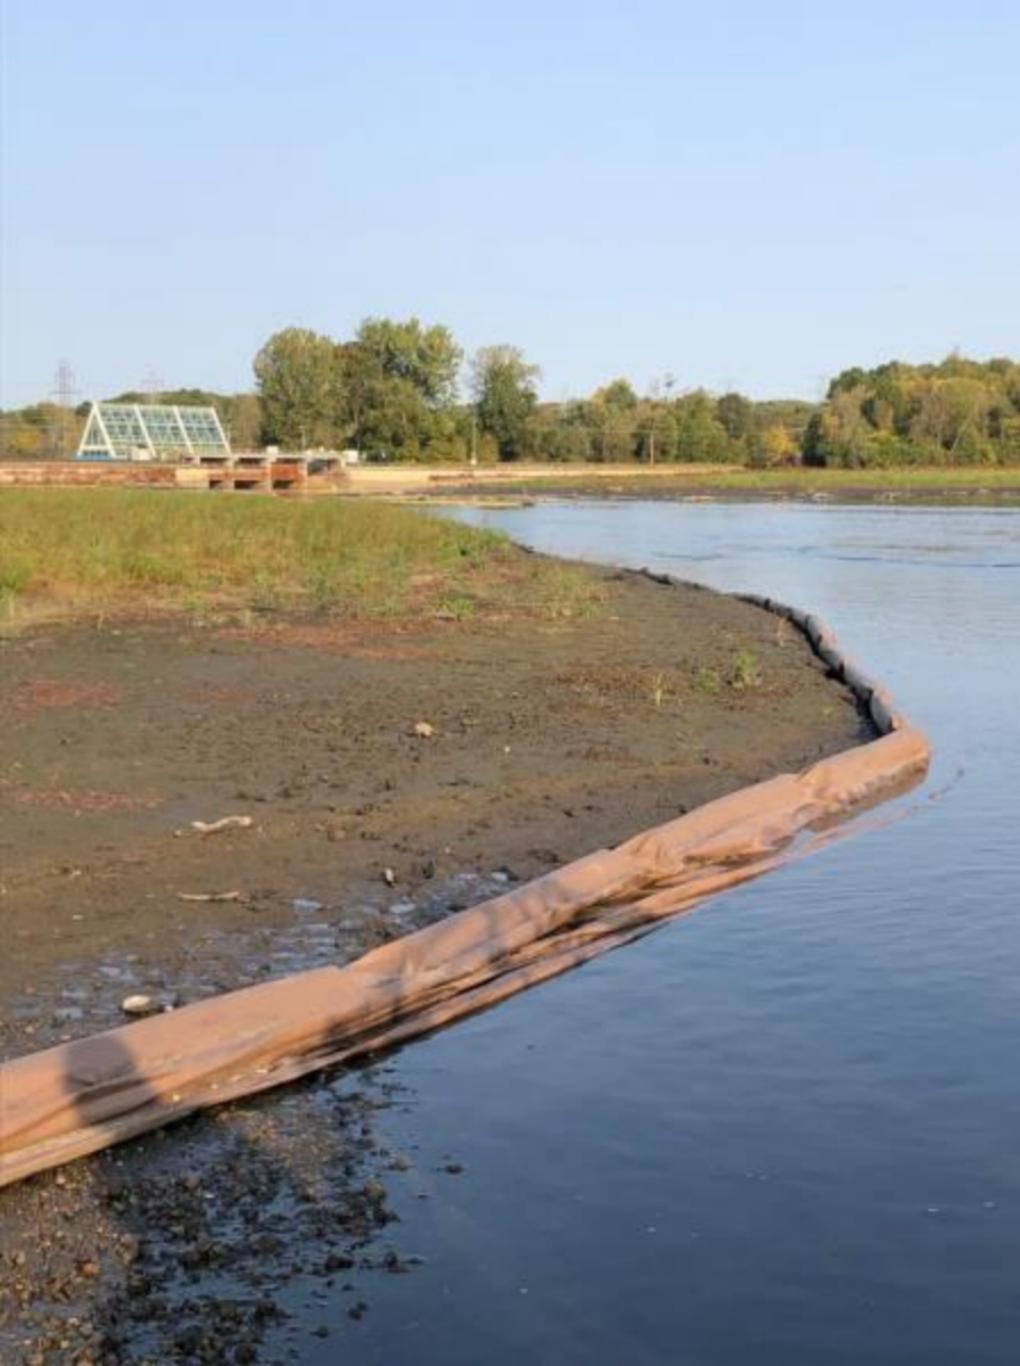
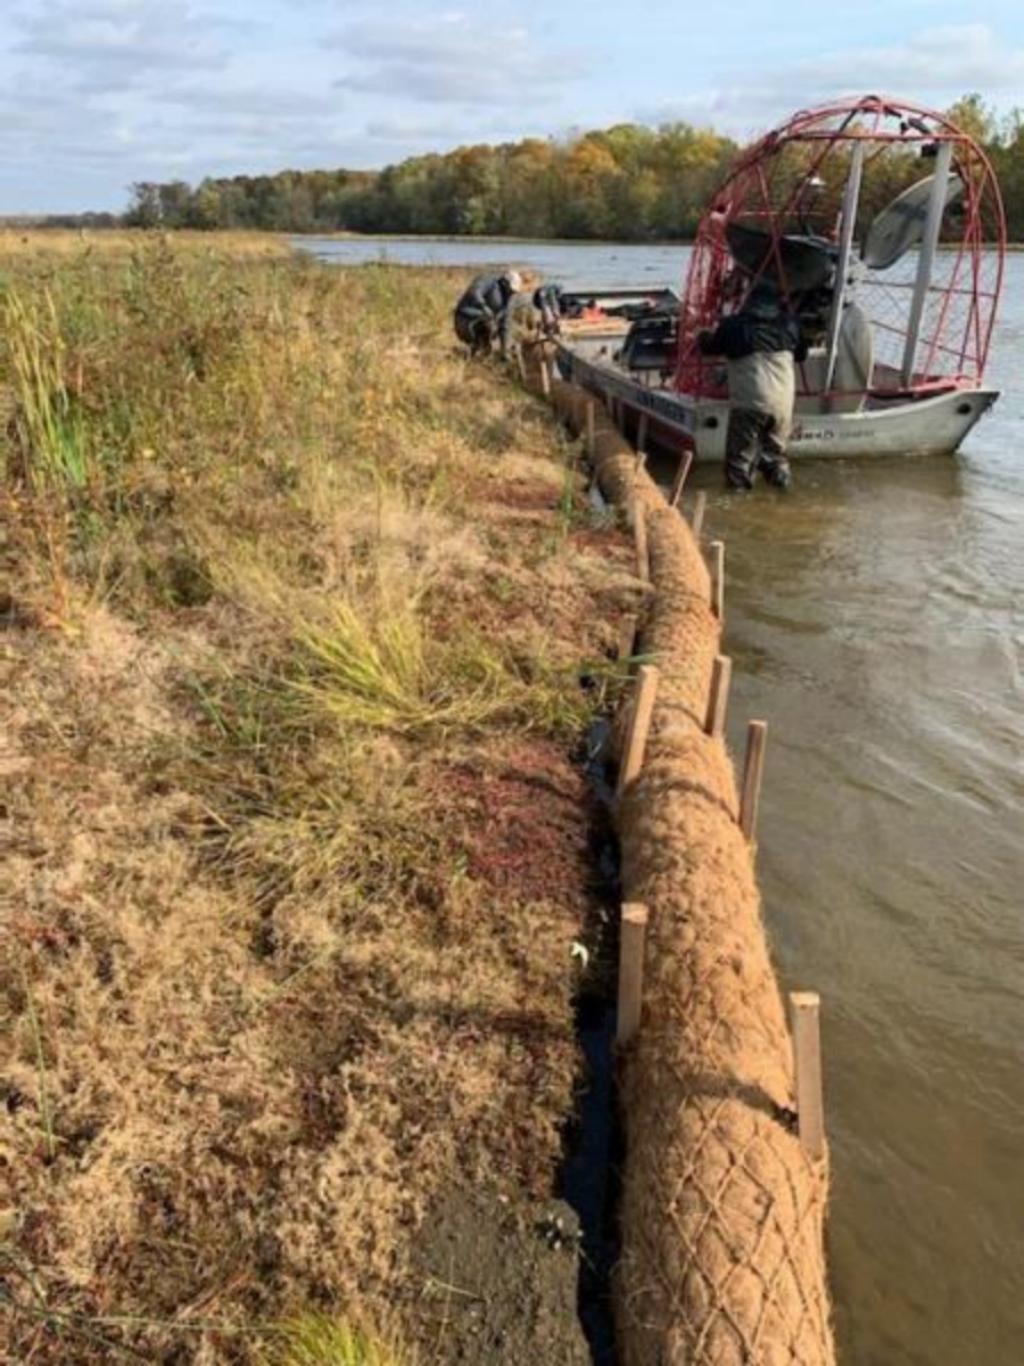
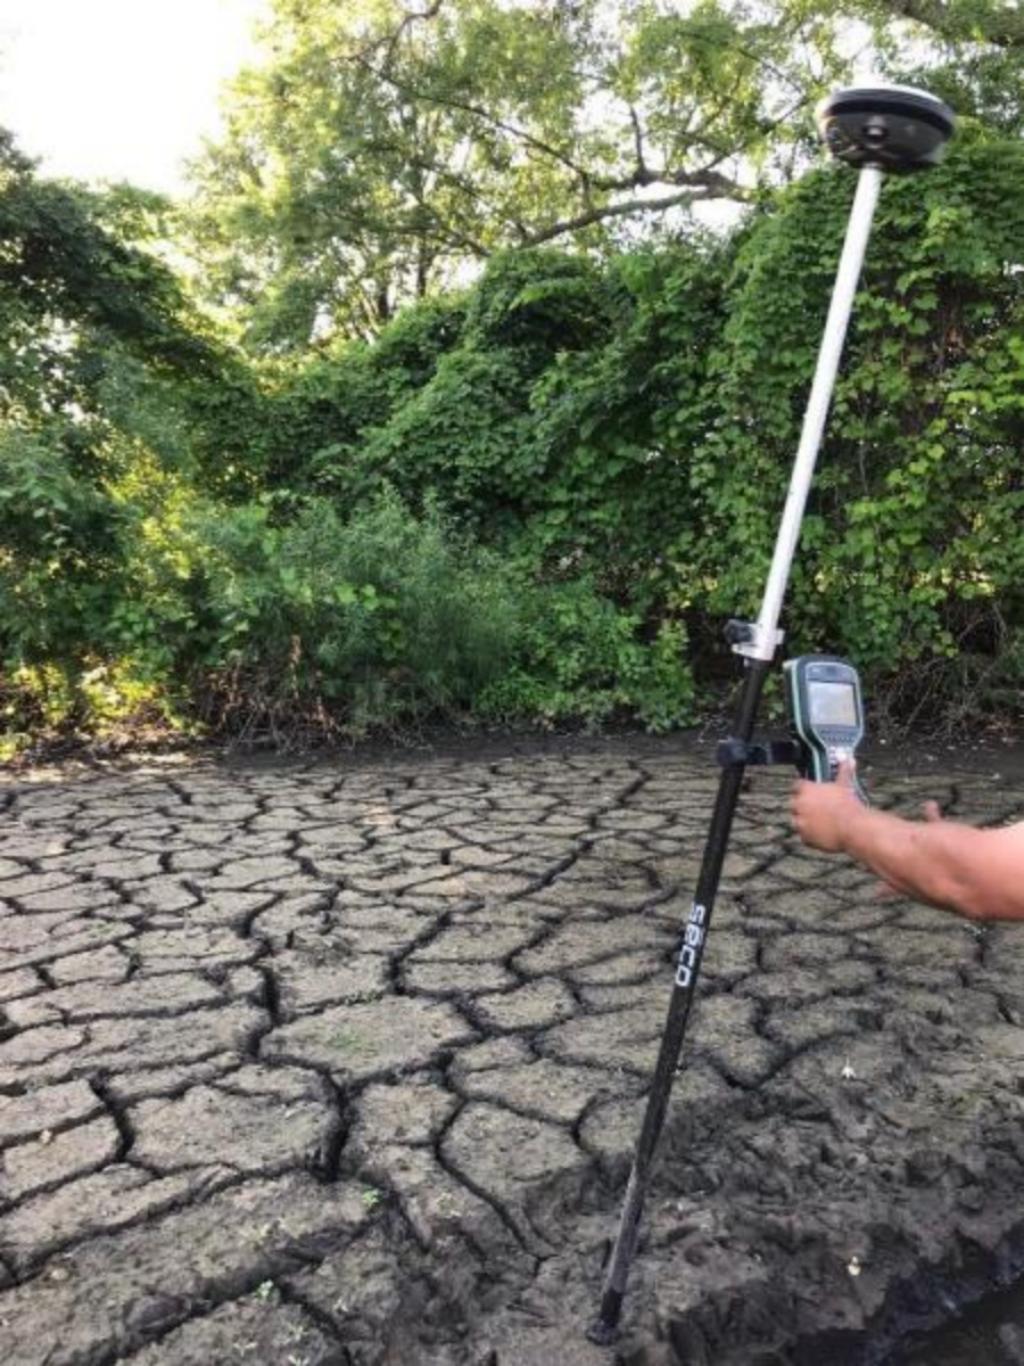
In addition to sediment containment controls already in place, a contractor to STS (SWAT) installed approximately 5000 linear feet of sediment curtain in active erosional areas upstream of the dam within Morrow Lake identified during field reconnaissance (see photo). In addition, coir logs were installed in other areas susceptible to erosion during high water events upstream of the dam in Morrow Lake (see photo). Sediment control measures were also maintained and reinforced immediately downstream of the dam along mobilized sediment deposits susceptible to further mobilization downriver.
